REPORT

Nestlé Waters Canada Erin Spring Site
2018 Annual Monitoring Report

Golder Associates Ltd.

13-1152-0250 (2000)

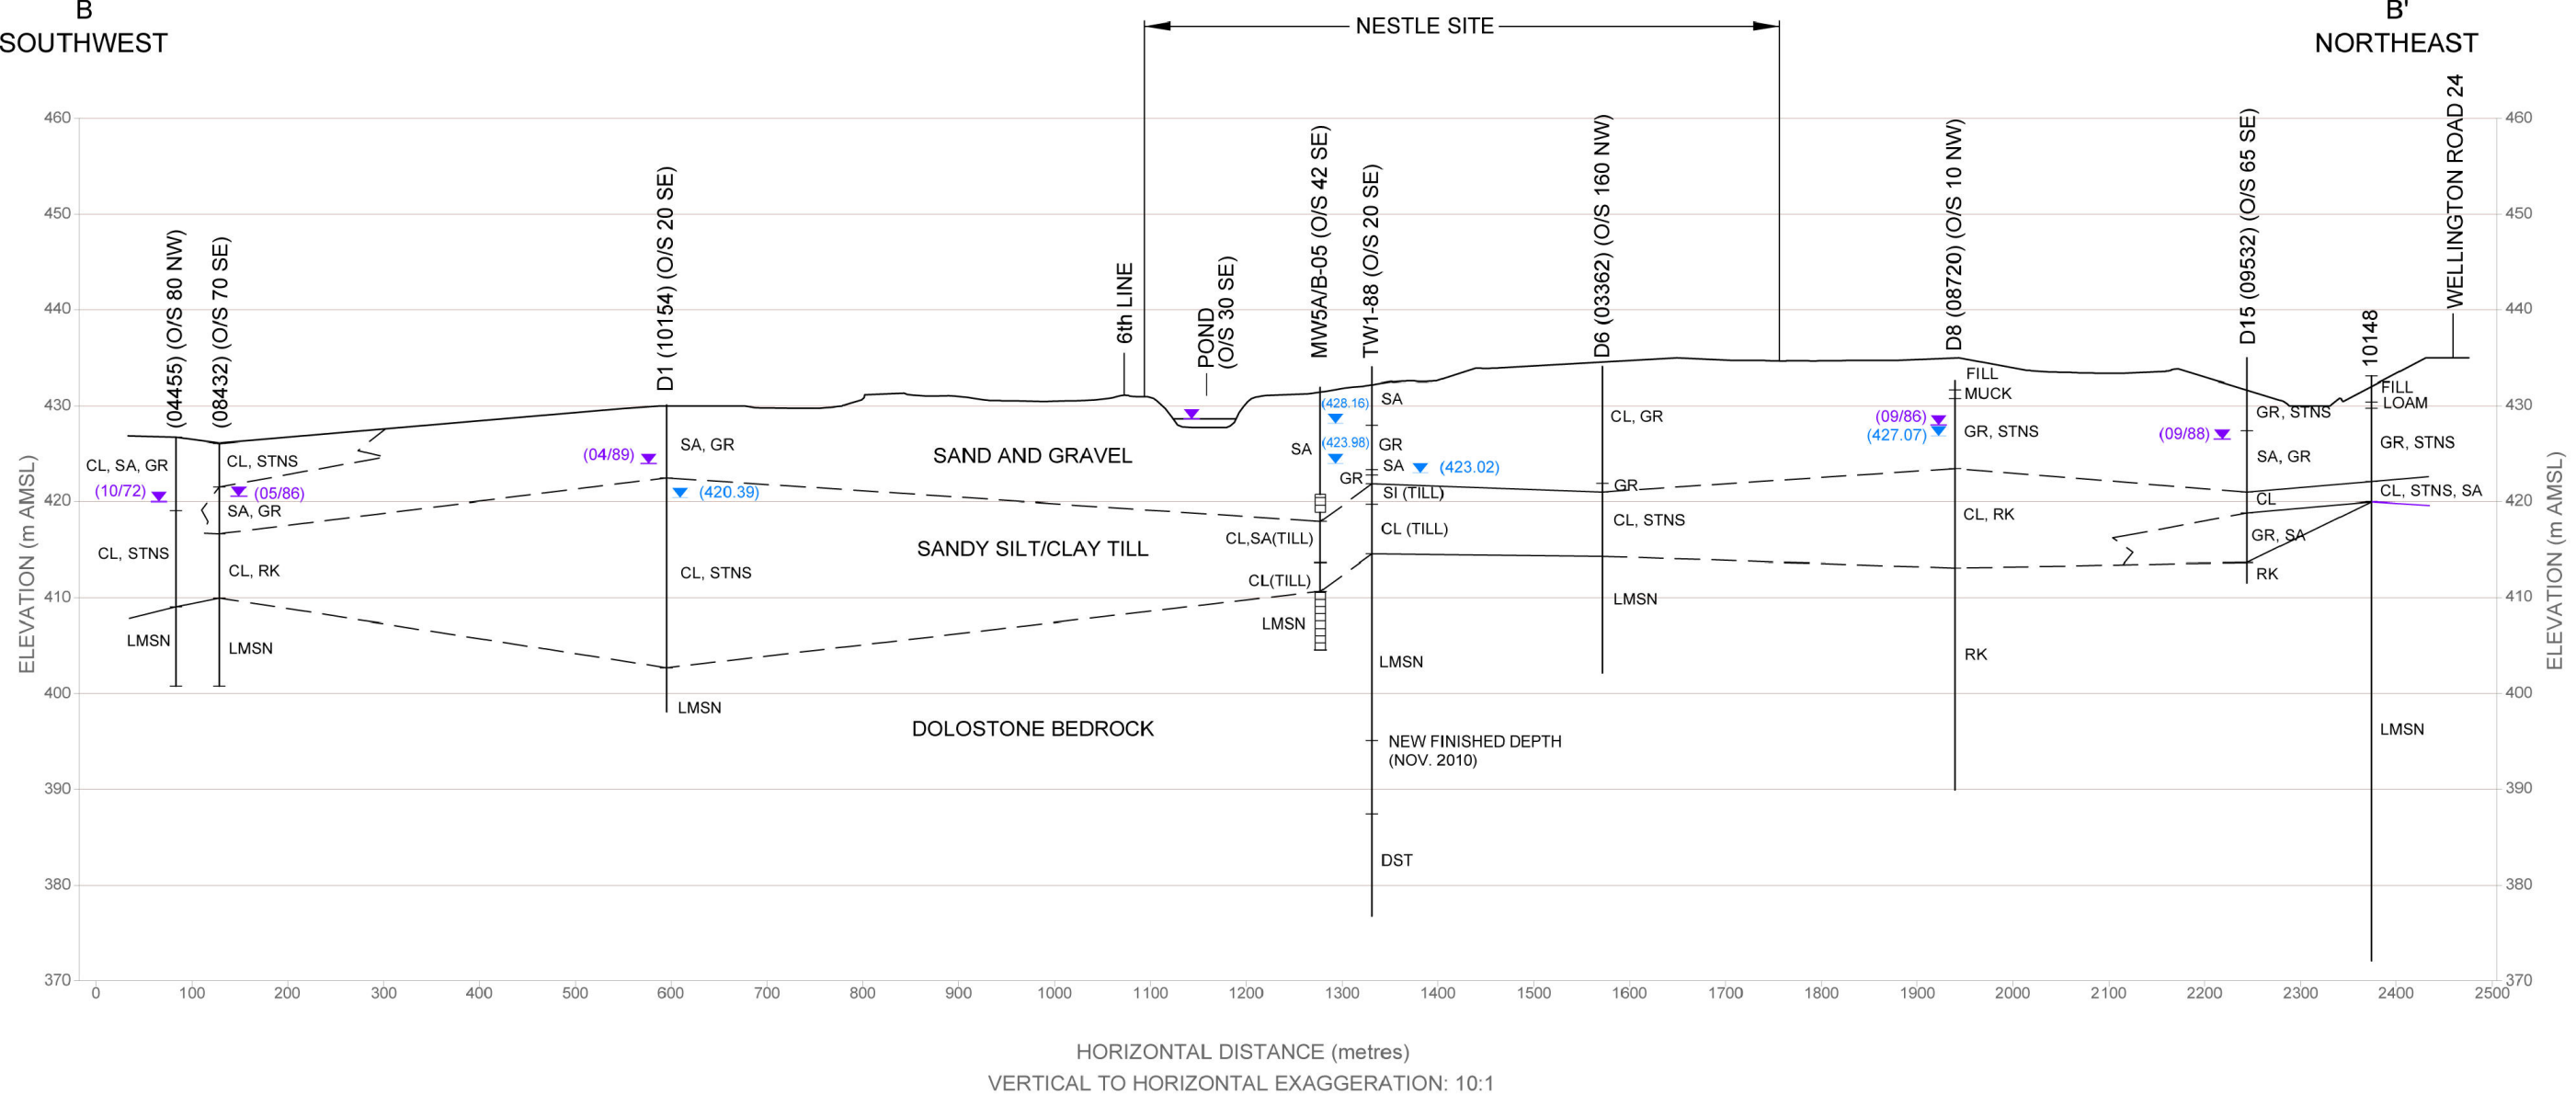
PROJECT NO. 13-1152-0250 (2000) CONTROL 0016 REV. 1.0 FIGURE 2.4

HORIZONTAL DISTANCE (metres)
VERTICAL TO HORIZONTAL EXAGGERATION: 10:1

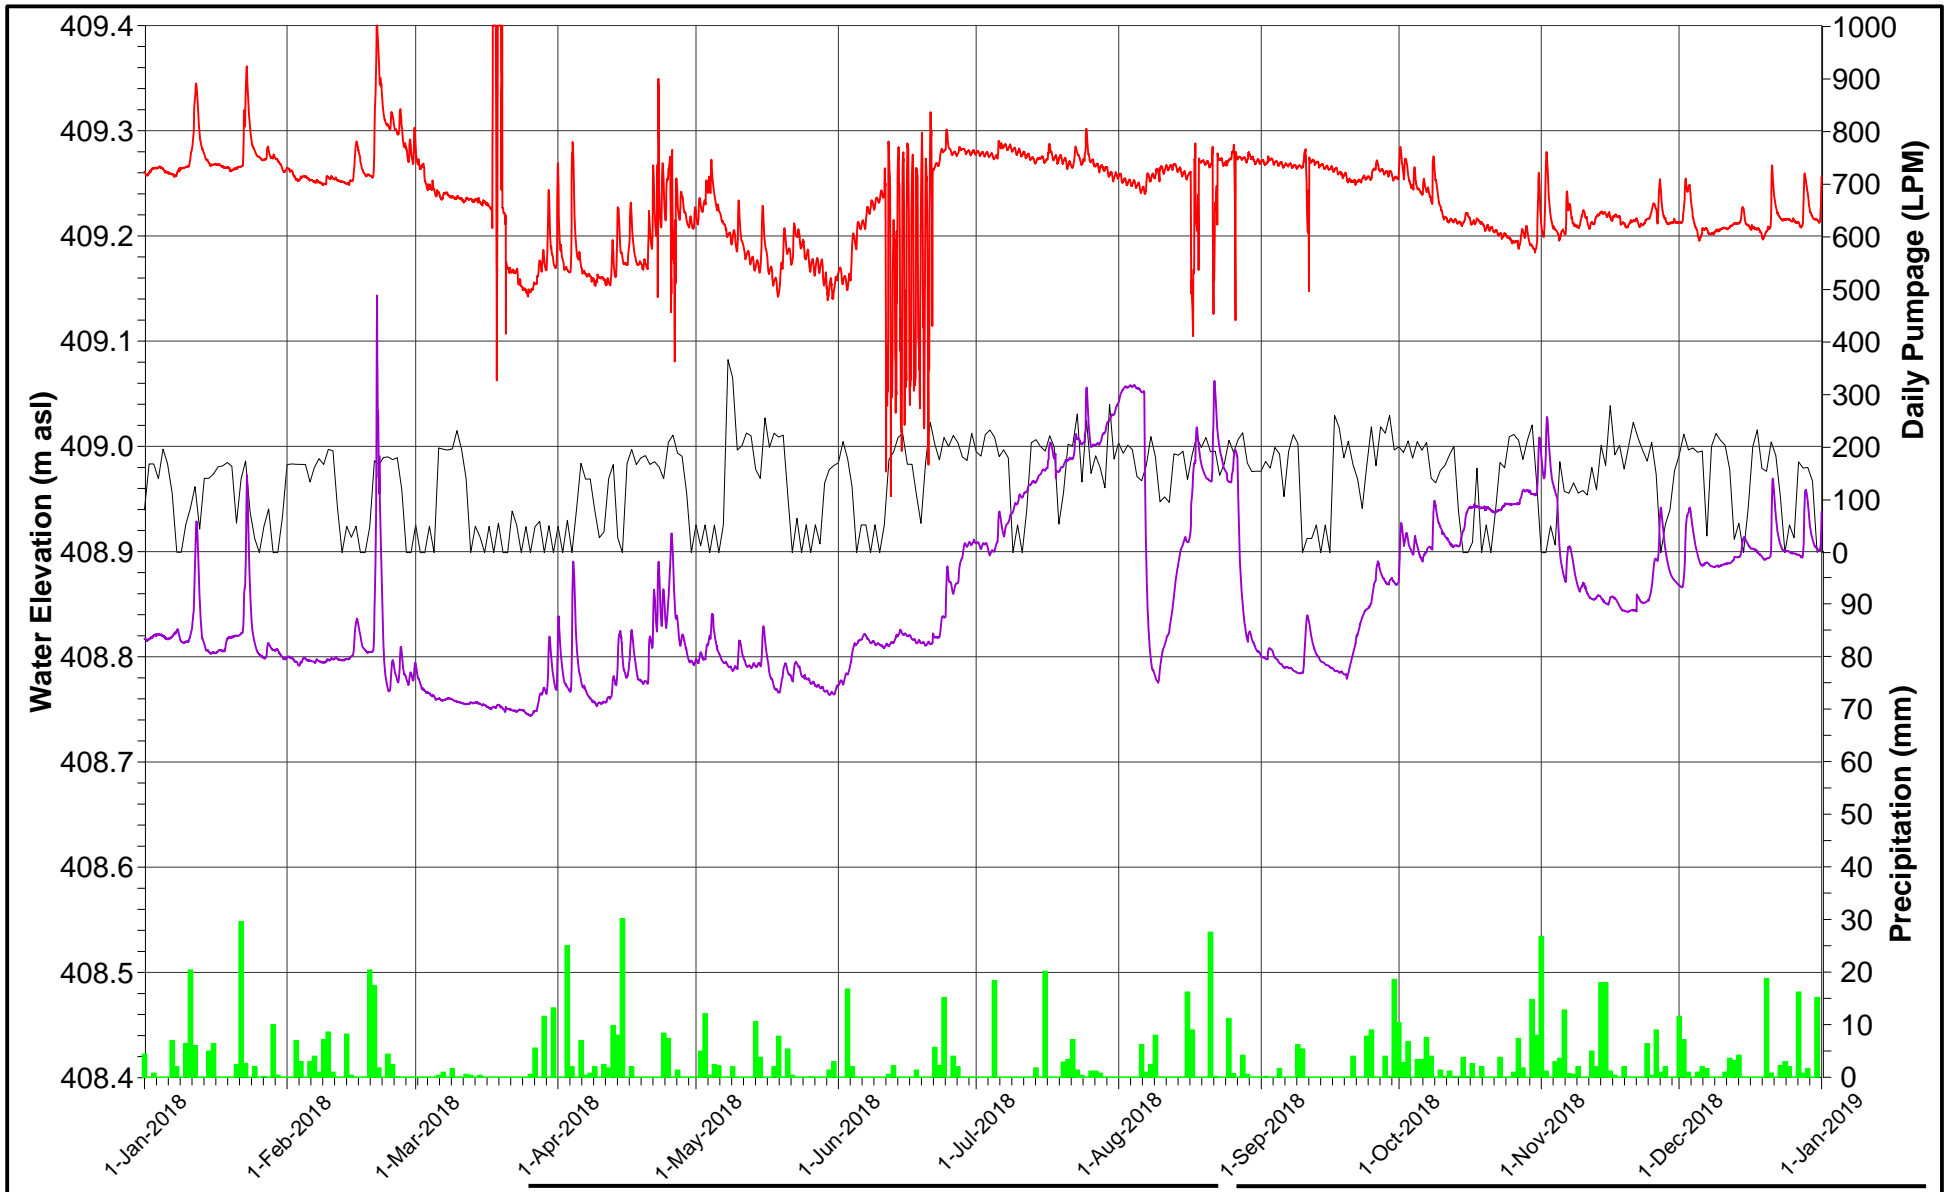
PROJECT NO. 13-1152-0250 (2000)	REV A	FIGURE E11a
---	-----------------	-----------------------

TITLE
**HYDROGRAPHS FOR SURFACE WATER LEVELS
IN VICINITY OF ROMAN LAKE
2018 ANNUAL MONITORING REPORT**

- TW1-88 Daily Pumpage
- █ Precipitation
- SW4-08 (Stream into Roman Lake)
- SW5-08 (Roman Lake)
