Blue Triton Brands Erin Spring Site
2022 Annual Monitoring Report

WSP Canada Inc.

20449101

March 2023

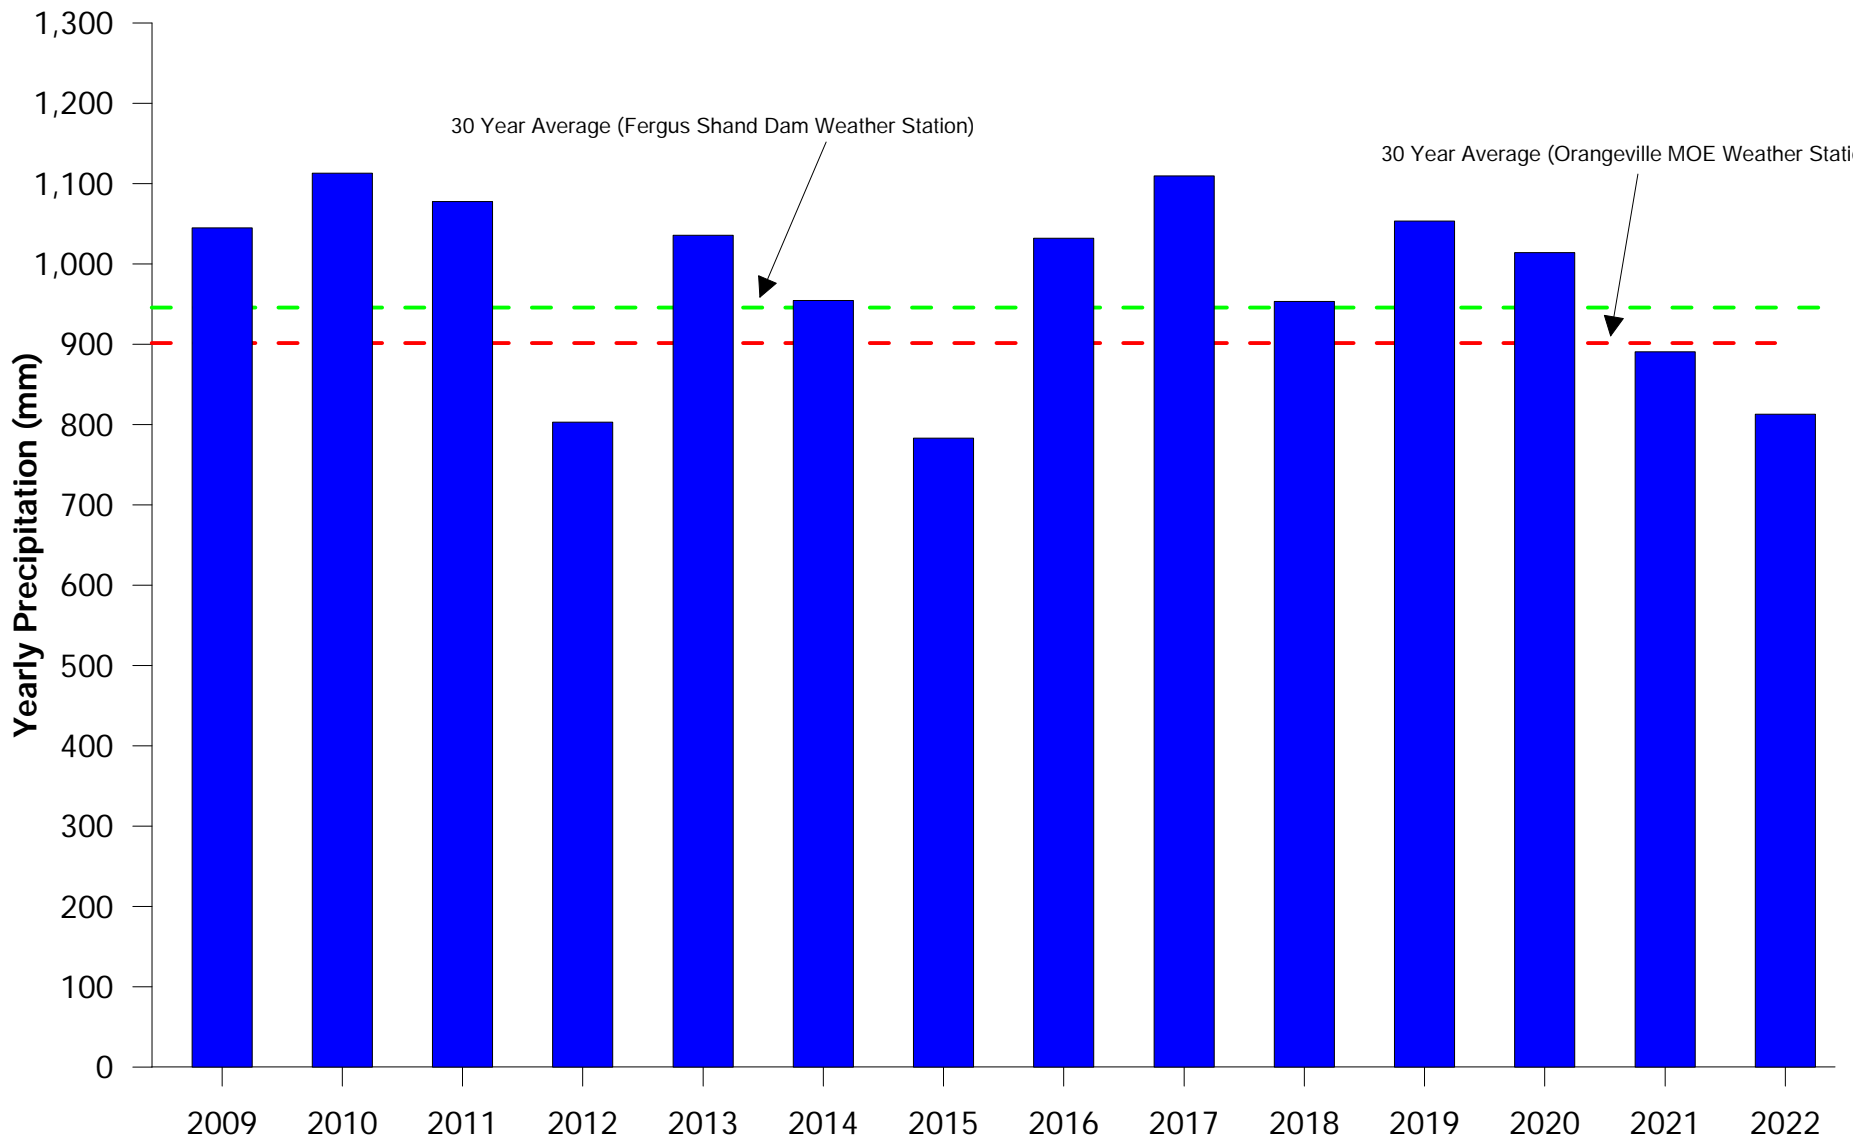
FIGURE 3.5

Data for Orangeville Station prior to 2016, and data for Shand Dam Station from 2016-2022

A record of precipitation in 2022 was compiled from the Fergus Shand Dam meteorological station with missing data filled in from the Elora RCS meteorological station. Missing data were previously filled in from the Fergus MOE meteorological station, but the data were not available after 2020. Prior to 2016, the record of precipitation was compiled from the Orangeville meteorological station, with missing data obtained from the Fergus Shand Dam Station; however, data are no longer available from the Orangeville station. The following table provides a summary of the annual precipitation. The annual average (1981-2010) precipitation at the Fergus Shand Dam Station is 945.7 mm and it is 901.5 mm at the Orangeville Station. The total precipitation measured in 2022 was 812.9 mm, which is approximately 14% below the 1981-2010 average. The total annual precipitation has declined

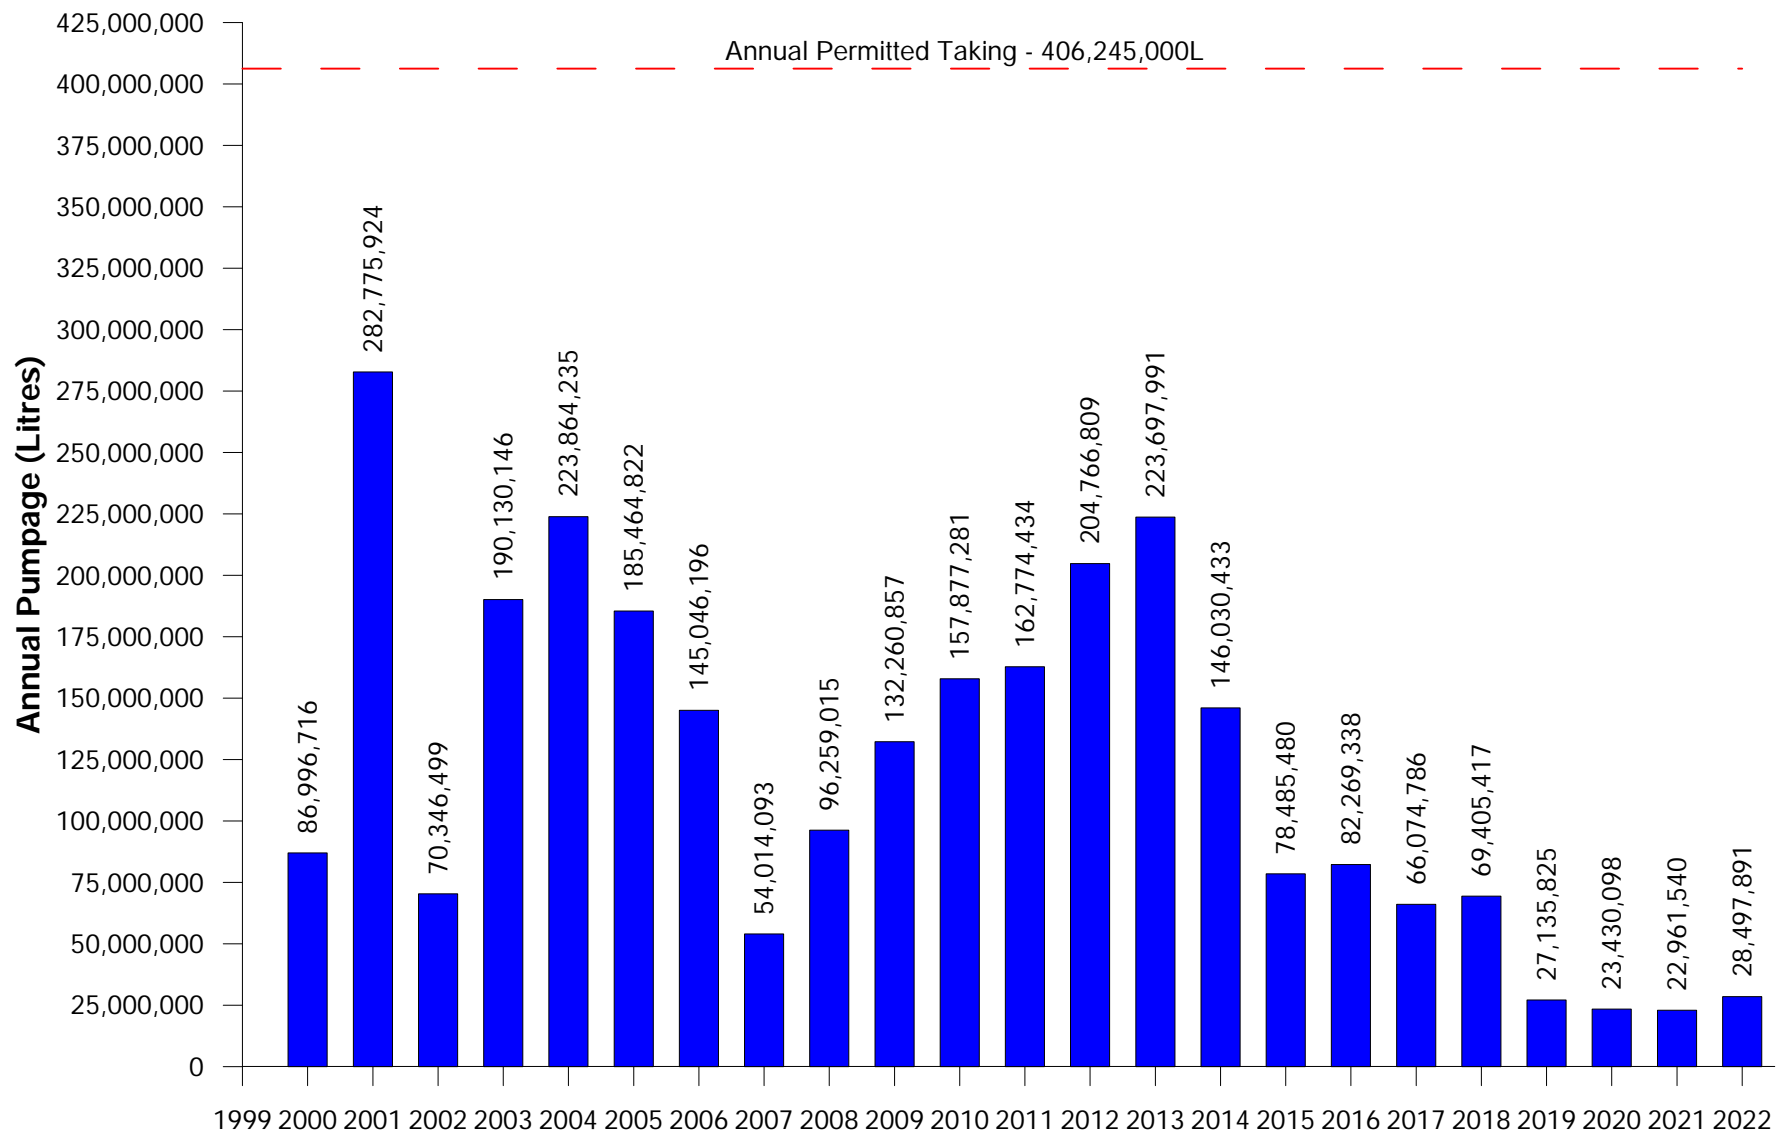
PROJECT NO. 20449101 (2100) REV A FIGURE 4.1

Annual Permitted Taking - 406,245,000L

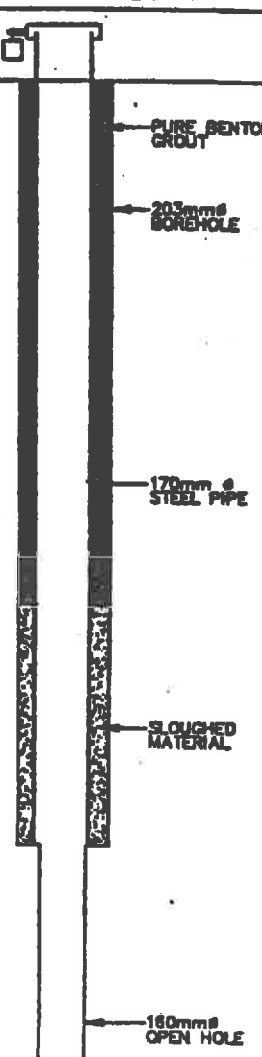
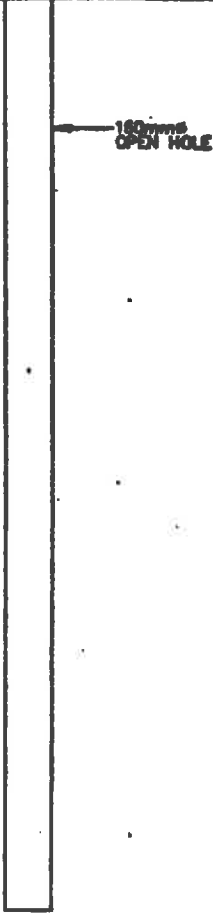
2.5	TOPSOIL—sand, some silt, little gravel, compact rootlets, humus material, brown, moist SM (SAND)—some silt, trace of fine gravel, compact, medium grained, poorly graded, brown, moist	429.5

47.5	Dolostone, dark grey to black	383.4				
50.0	- fracture, clay filled 100 to 150mm, brown					
52.5	- fracture 100 to 150mm, clay filled					
55.0	- fracture 100 to 200mm, unfilled					
57.5	- sound, unfractured, crystalline, basal to concoidal fracture, grey.	372.7				
60.0	END OF HOLE @ 57.30m BGS. NOTE: 1. Casing set to 20.88m BGS and grouted into bedrock using a pure bentonite grout. 2. All elevations are approximate.					
62.5						
65.0
